ORLO VISTA FLOOD MITIGATION PROJECT UPDATE

November 13, 2024

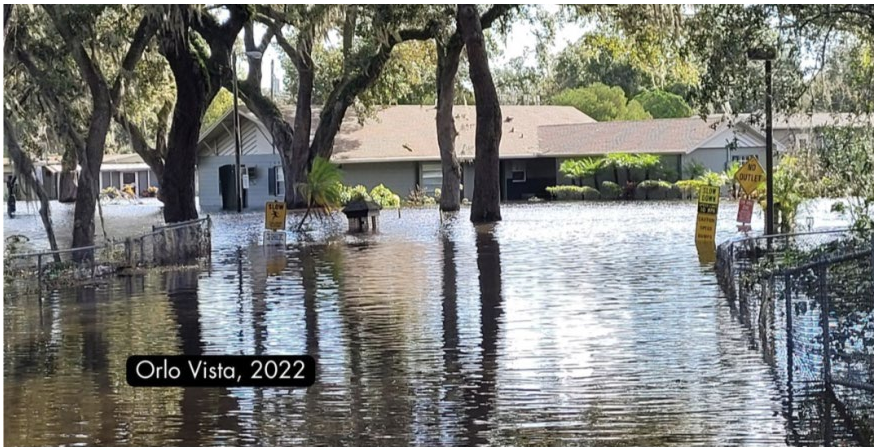
Orlo Vista, 2022

The Orlo Vista neighborhood in Orange County demonstrated remarkable resilience during Hurricane Milton in October 2024, thanks to this major flood mitigation project. This success story is a welcome change from the severe flooding experienced during Hurricanes Irma in 2017 and Ian in 2022. Despite receiving a substantial 9.46 inches of rainfall over 34 hours, the Orlo Vista and Westside Manor areas remained largely unaffected. The newly implemented drainage improvements proved highly effective, with no significant flooding reported and homes staying dry. This outcome provided much-needed reassurance to local residents, validating the project's effectiveness and the county's efforts to protect the community from future flood events. The Orlo Vista Flood Mitigation Project, which was approximately 97% complete at the time of Hurricane Milton, played a crucial role in preventing flooding. The project involved expanding the capacity of three retention ponds by making them deeper, effectively tripling their water storage capability. Additionally, a well-coordinated pumping strategy and the deployment of four extra temporary pumps enhanced water control both prior to and during the storm. The team lowered water levels in the ponds before Hurricane Milton, effectively utilizing the increased flood storage capacity created by the excavation work.

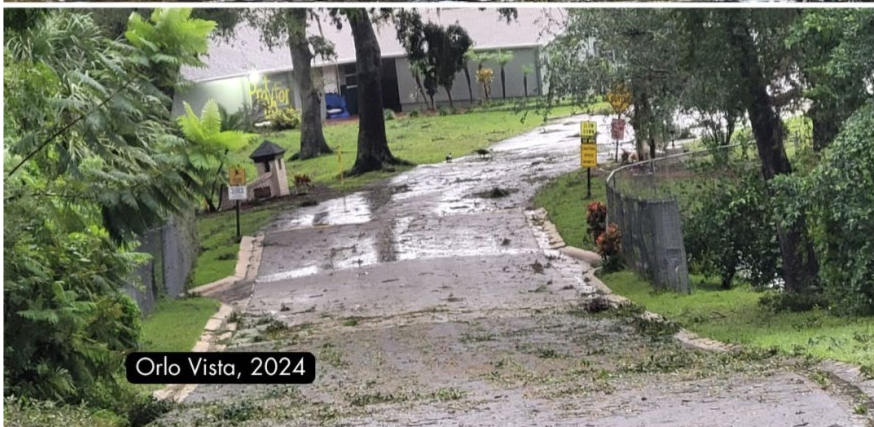
Orlo Vista, 2024

This successful outcome not only demonstrates the effectiveness of the flood mitigation efforts but also provides a sense of security for Orlo Vista residents who have faced repeated flooding in the past. The project's ability to handle a 100-year storm event showcases the significant progress made in protecting this vulnerable area from future flooding events.

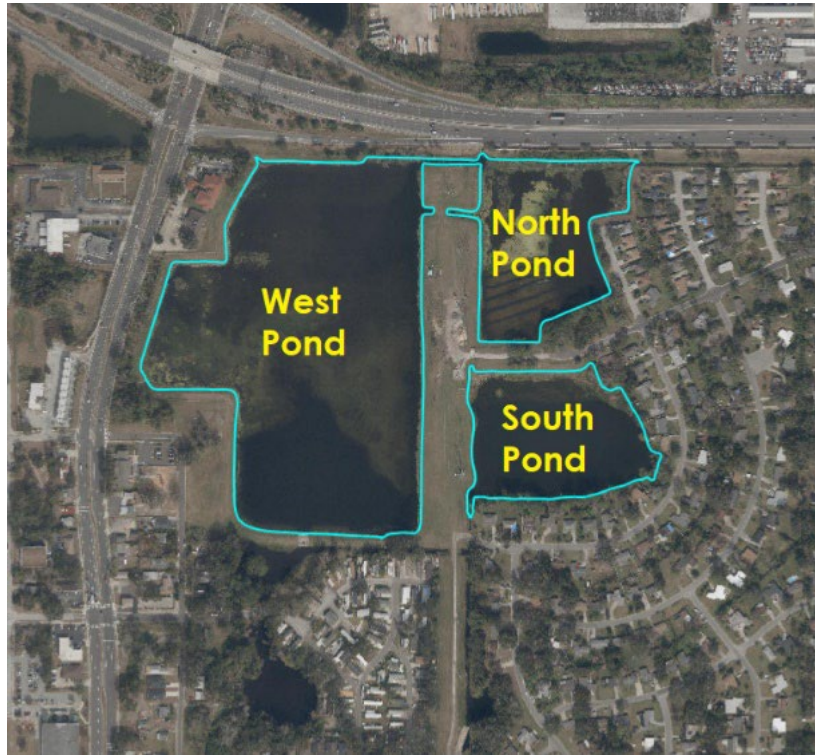
Figure 1 - Orlo Vista Ponds

Orlo Vista Flood Mitigation Construction project is a large project that incorporates three ponds: West, North, and South ponds (see Figure 1). The project also encompasses four main items: excavation, geoweb installation (erosion control), pump station, and pipe installation. The table below shows the progress of the project for each of these items.
