ORLO VISTA FLOOD MITIGATION PROJECT UPDATE

November 13, 2024

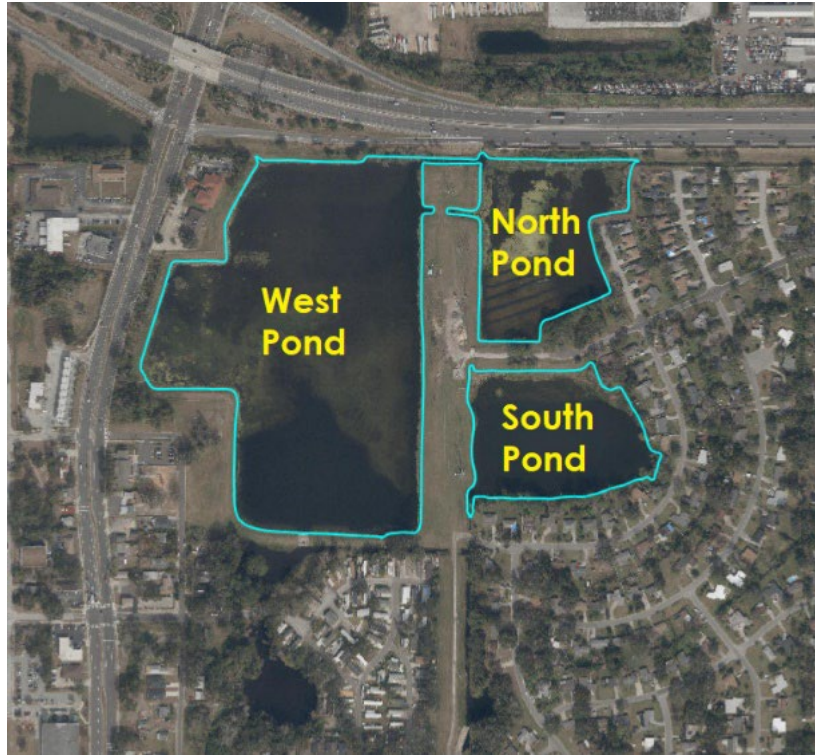
Figure 1 - Orlo Vista Ponds

Orlo Vista Flood Mitigation Construction project is a large project that incorporates three ponds: West, North, and South ponds (see Figure 1). The project also encompasses four main items: excavation, geoweb installation (erosion control), pump station, and pipe installation. The table below shows the progress of the project for each of these items.

Below is a detailed description of the construction progress to date.

North Pond:

- Excavation: Completed (95,700 cubic yards of material, 100% complete)).
- Geoweb Installation: Fully installed.
- Ground Stabilization: Hydroseed placed above Geoweb, with sod installation ongoing.
- Installed sod above Geoweb west side of North Pond

South Pond:

- Excavation: Completed (58,356 cubic yards of material, 100% complete).
- Geoweb Installation: Fully installed
- Ground Stabilization: Hydroseed placed above Geoweb, with sod installation ongoing.
- Installed sod above Geoweb west side of South Pond

West Pond:

- Excavation: Completed (371,922 cubic yards of material, 100% complete).
- Geoweb Installation: In progress (approximately 99% complete).
- Repairing damaged area of south side of West Pond from Hurricane Milton
- Progress on Drainage: Construction of headwall and 349 linear feet of 48-inch RCP is complete.
- Ground Stabilization: Sod placement ongoing.
