ORLO VISTA FLOOD MITIGATION PROJECT UPDATE

February 18, 2025

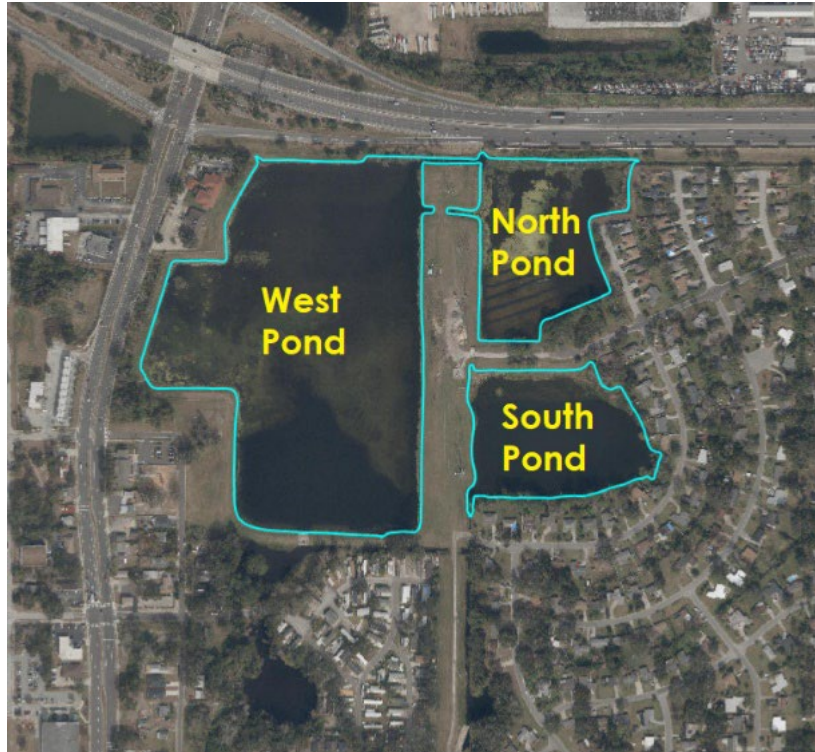
Figure 1 - Orlo Vista Ponds

Orlo Vista Flood Mitigation Construction project is a large project that incorporates three ponds: West, North, and South ponds (see Figure 1). The project also encompasses four main items: excavation, geoweb installation (erosion control), pump station, and pipe installation. The table below shows the progress of the project for each of these items.
